Eurolec Warranty Policy for Starter Motors And Alternators

Effective August 2014

Eurolec Warranty Policy – Visual Inspection Chart for all units

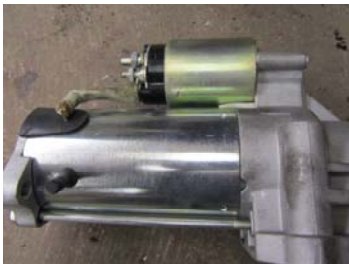
The solenoid was changed on this unit

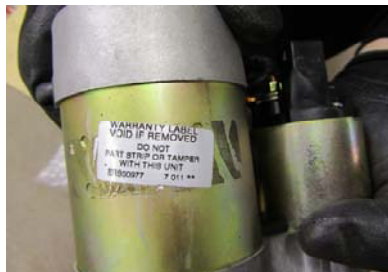
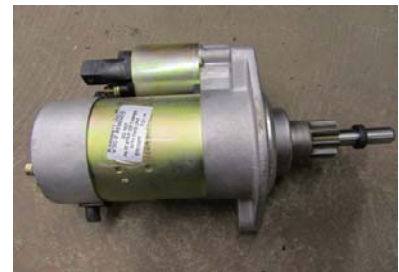
The label from a Eurolec unit was removed and placed on this non-Eurolec unit.

We know all of our units! All product purchased by us or re-manufactured in our factory is easily recognisable by our warranty department. If we believe the unit is not ours, warranty will be rejected. All Eurolec units have a unique ID label stating part number, date of manufacture or supply. If this label is missing, warranty will not be honoured.

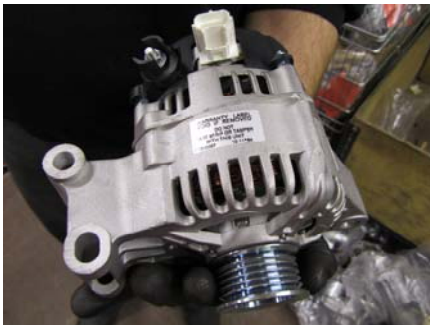
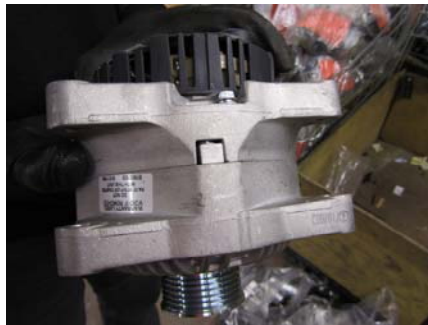
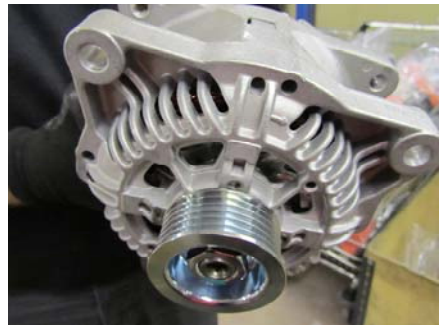
These units had never been fitted – there are no wear / abrasion marks around the bracket holes that indicate fitment, and there are no wear marks on the pulley suggesting no belt has been fitted

Without doubt the biggest single reason that we reject warranty. Having been involved with rotating electrics for nearly 40 years, we can spot a false warranty claim a mile off! Many units returned to us have no evident fault, and many have never even been fitted to a vehicle. In this instance, we will reject warranty and the product will be returned to the customer.

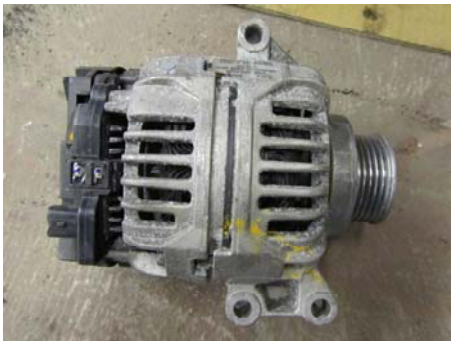
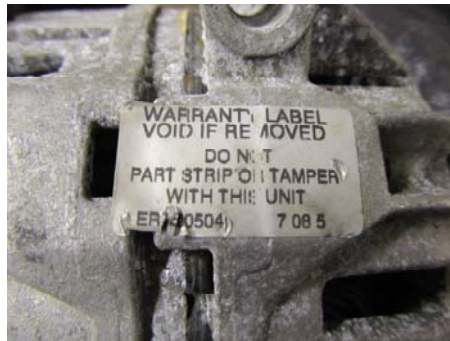
This alternator was recently returned to us (March 2012) after three years service. The internal indications (the state of the bearings, wear to the brushes and slip ring) suggested well over 100,000 miles. The customer still tried to claim warranty.

All Eurolec units have a production date on the label, which is an indication to the age of a returned unit. The warranty period begins from the date the unit is sold to the customer, and lasts 12 months from that date. We understand that some units may have a “shelf life” prior to sale, and we will use our discretion when agreeing warranty

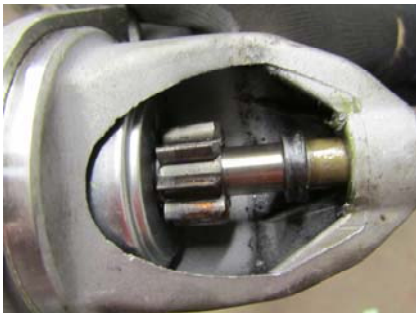
Red / blue burn marks around pinion teeth

A common fault with starter motors is the failure of an ignition switch or starter relay. This will cause the starter motor to be permanently engaged, and the motor will eventually burn out. This is evident from the red / blue burn marks around the drive teeth and armature shaft, and by the obvious smell of burning! If this is evident, we will reject any

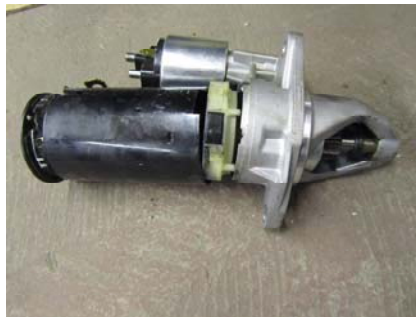
Unit held in mesh, causing collapse of brushes, brush box and armature coils

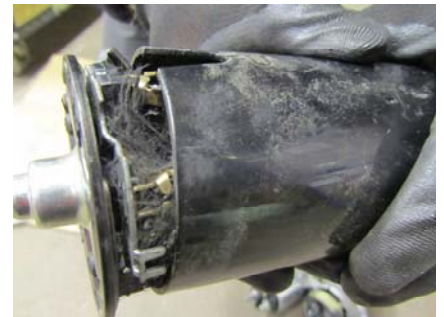
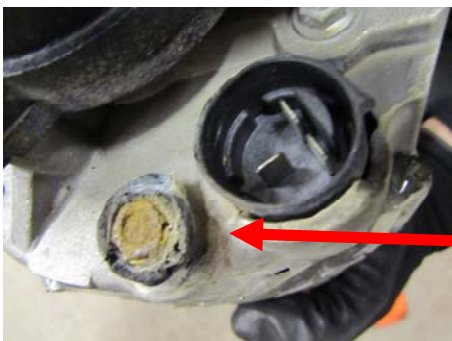
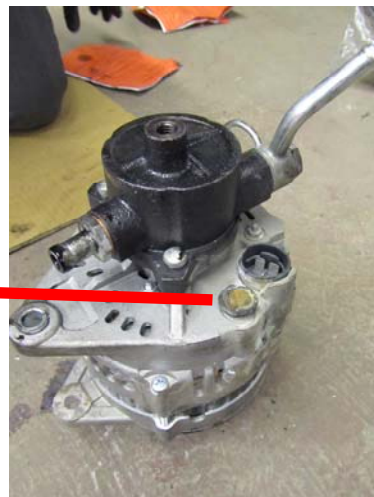
Alternator burnt out / incorrectly wired

Incorrect wiring of an alternator is a common problem. Terminals, plugs and connections are frequently wired incorrectly, causing the failure of component parts such as the regulator and rectifier. In certain cases, this will cause the alternator to “burn out” as the incorrect wiring leads to the electric feed melting terminals. If this is evident, we will reject any warranty.

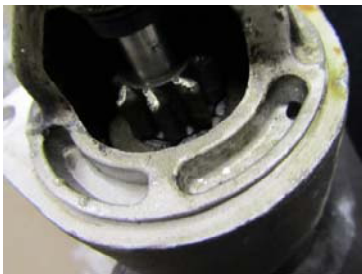
Damage to the teeth on this starter motor has been caused by either an incorrect fitment or the wrong ring gear

Many units are incorrectly fitted as a result of inaccurate fitment information. It is very important to get the information right before fitting a unit, or damage will inevitably occur. This will void any warranty

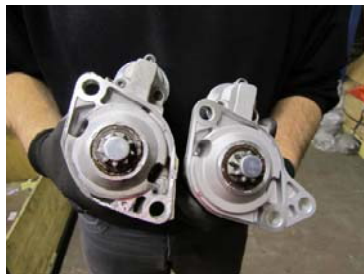
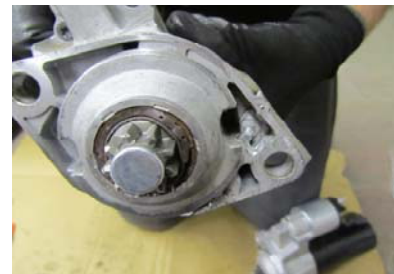
The unit on the left was "adapted" to fit as the unit on the right. Incorrect unit for the fitment, leading to extensive damage to the Eurolec unit
